## Proctor & Gamble

## CASE STUDY

# PAVECON

# Concrete Repair, New Base

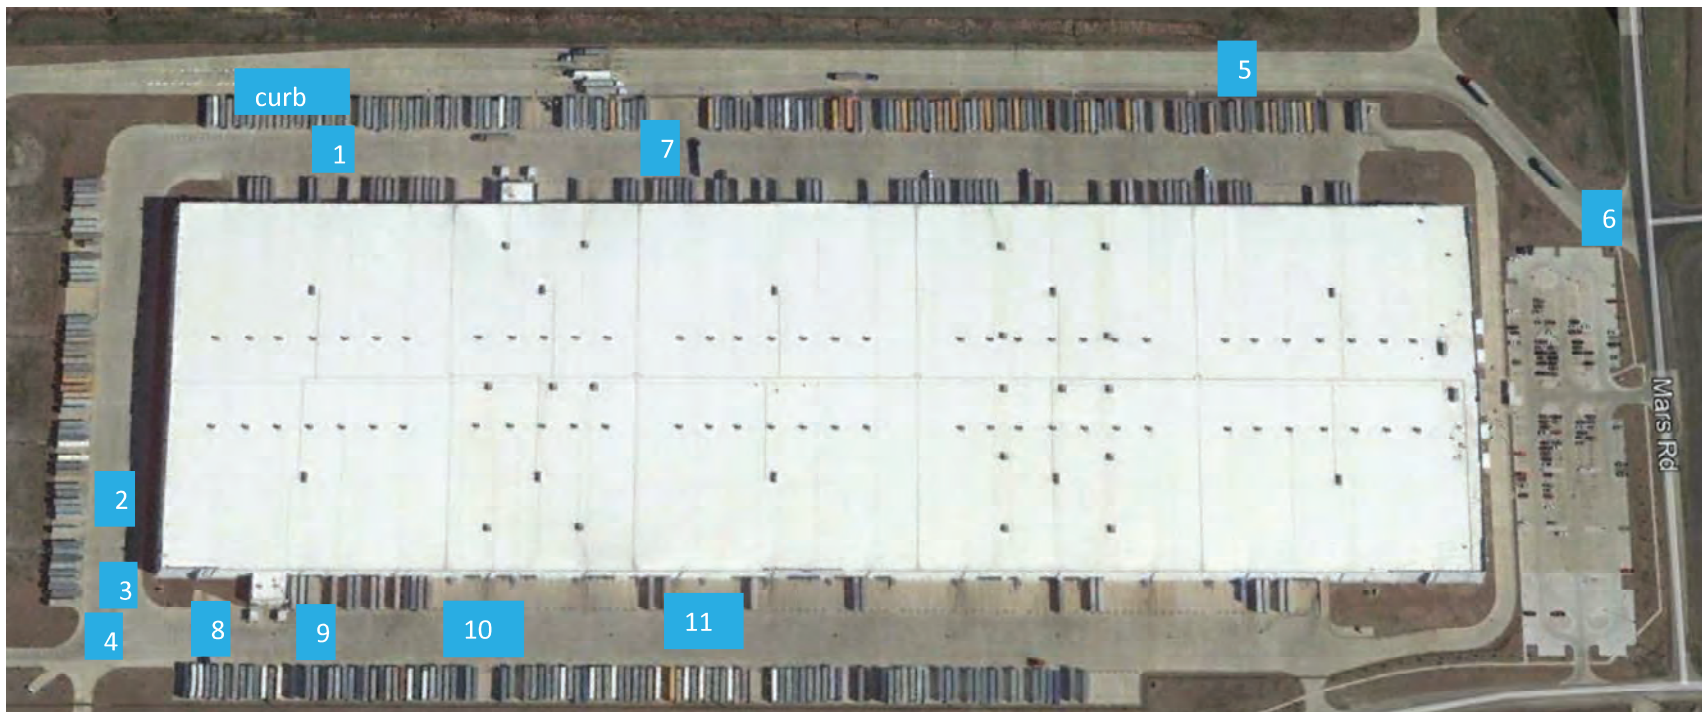
Area 1 : 45 X 15, 30 X 15  
Area 2 : 30 X 30, 15 X 15  
Area 3 : 45 X 30, 30 X 3

Area 4 : 30 X 30  
Area 5 : 45 X 30  
Area 6 :  $[1/2(28 \times 28) + 1/2(30 \times 15)] - 1/2(3 \times 3)$

Area 7 : 30 X 30  
Area 8 : 15 X 15

Area 9 : 30 X 30, 32 X 8, 10 X 2  
Area 10 : 30 X 30, 10 X 2  
Area 11 : 30 X 30, 15 X 15

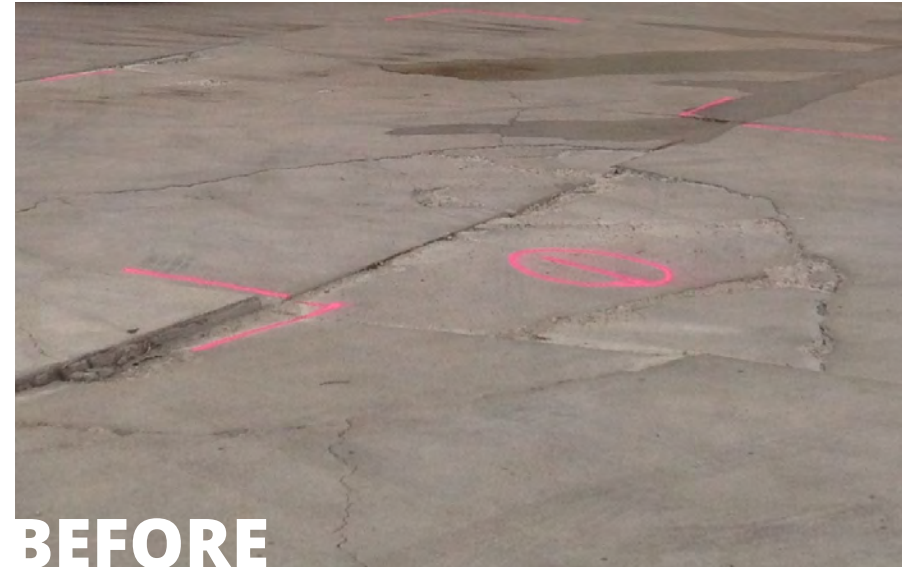
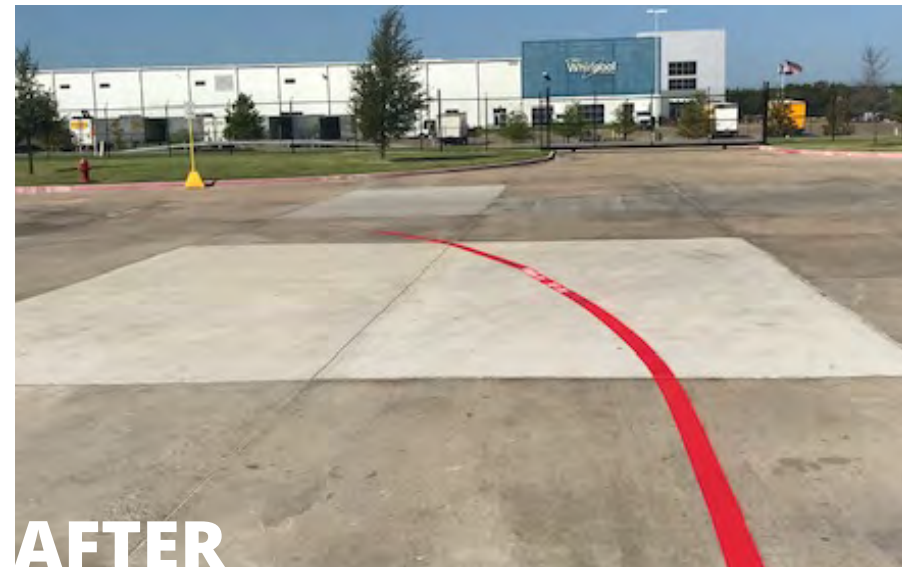
This distribution center had numerous failed areas due to poor construction when initially built or possibly inadequate design for the amount of traffic. Through subgrade analysis, a superior pavement design was created to handle the amount of traffic on a daily basis.

Heavy duty concrete repairs with base replacement.

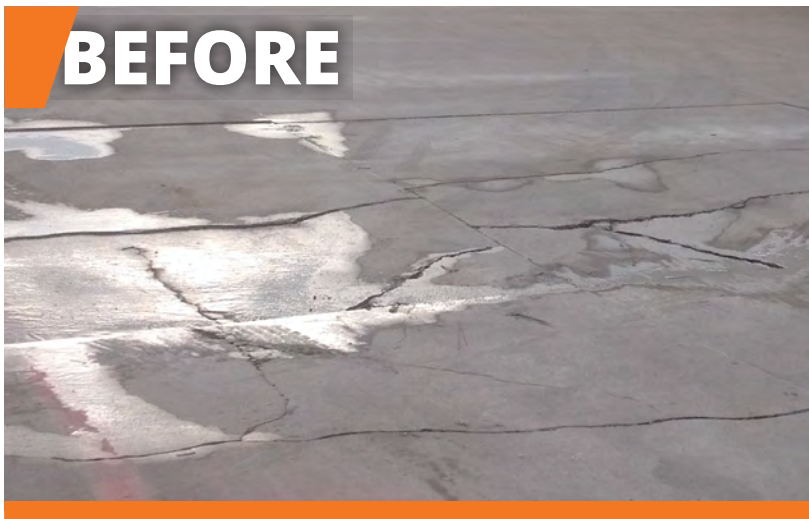
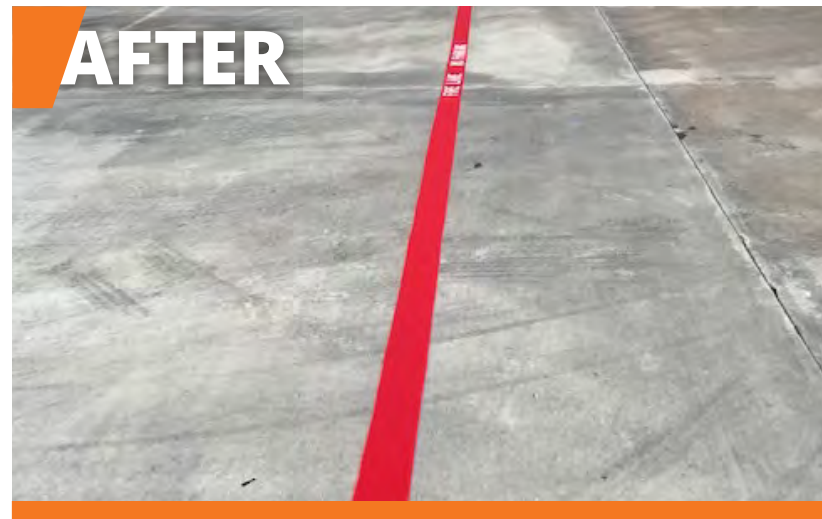
# Crack Sealing

Sealed vertical cracks in the fuel overflow containment pad.

The fuel overflow containment pad must be able to keep any fuel spilled from entering the surrounding grass.

Finding a fuel resistant vertical sealant.
